**MEMO**

ARCADIS Project No.:  
B0064530.0003.00907

Former Plainwell Impoundment and Plainwell No. 2 Dam Area Fall 2012 Bank Repair  
Plan Technical Memorandum – Revised November 2012

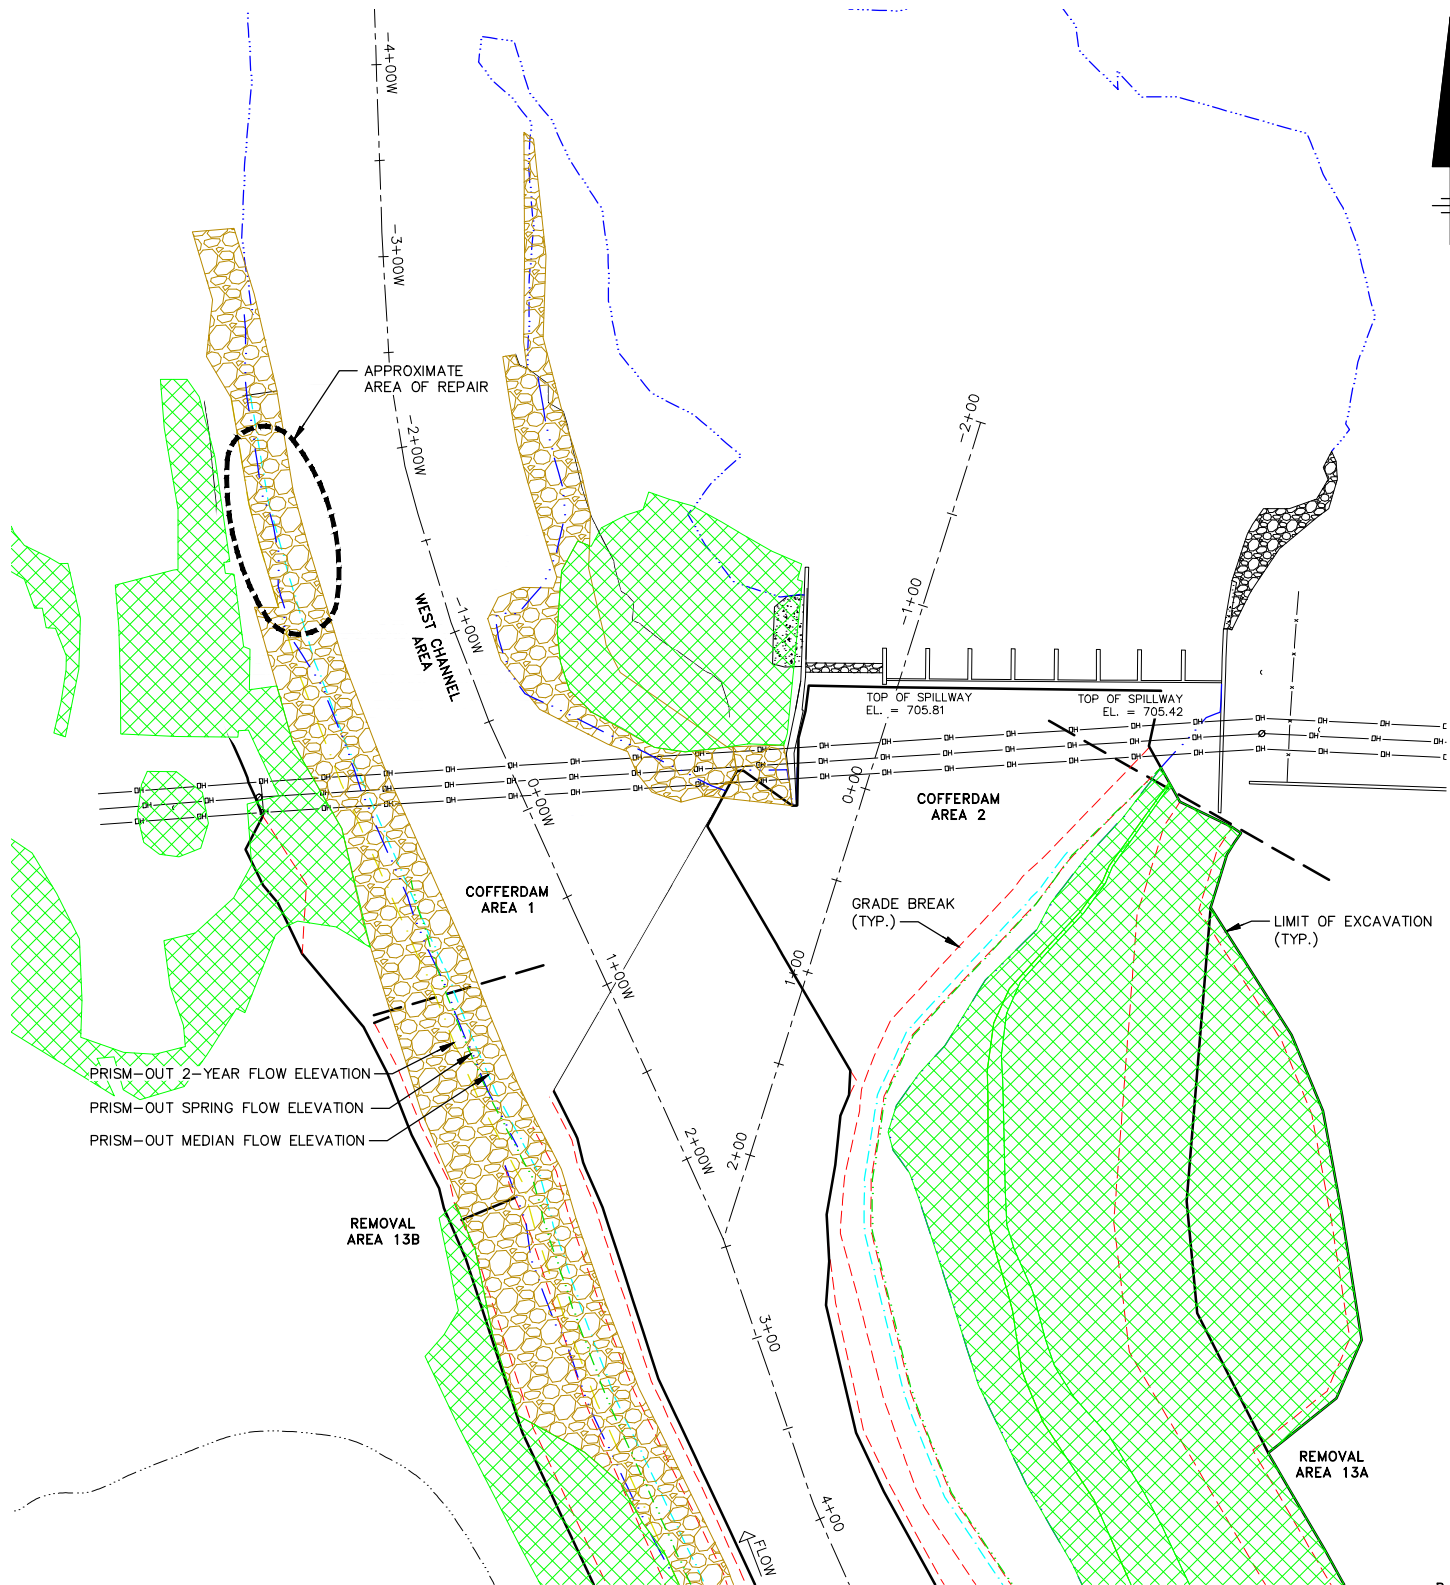
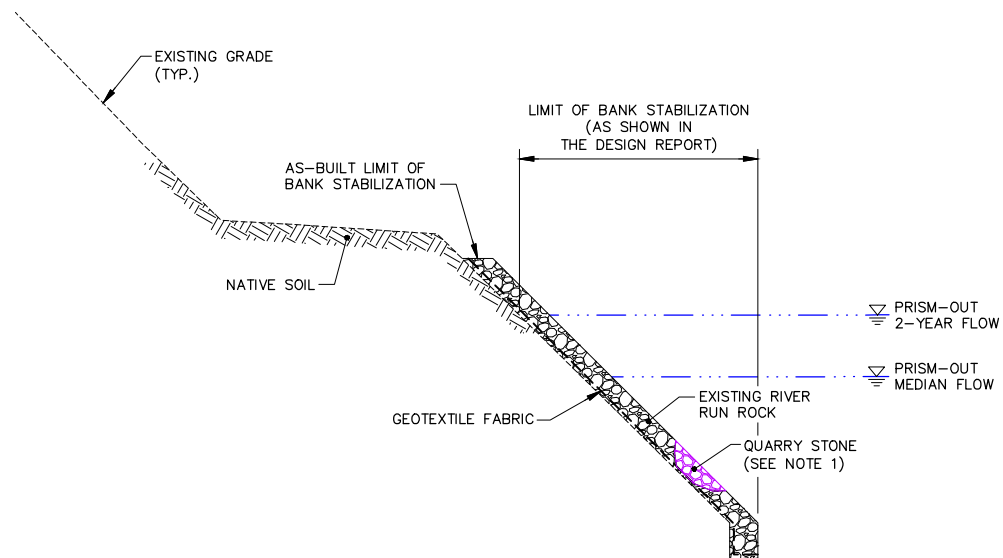
Figure 3 – Former Plainwell Impoundment Western Channel Proposed Bank Erosion Repair Plan and Cross-Section

During the August 30, 2012 and September 19, 2012 site walks, approximately 50 linear feet (ft) and 10 vertical ft of exposed geotextile fabric was observed on the south bank of the Western Channel downstream of the former Plainwell Dam (Figure 3). The geotextile was placed underneath the rock used for bank erosion protection as part of the TCRA. The exposed geotextile indicates that rock placed in this area has shifted towards the toe of slope, exposing the fabric, or that rock was not initially placed in this area since it was underwater at the time of construction and confirmation of placement of the intended amount and thickness of material over the complete extent of the area was difficult. This area is located immediately downstream of the Western Channel and is subject to the highest water velocities observed in the former Plainwell Impoundment.

According to the Former Plainwell Impoundment Design Report (ARCADIS BBL 2007), bank protection in the Western Channel was provided by a minimum 9-inch thick lift of rock with a mean diameter of 4 inches to the 2-year (prism-out) storm water elevation. The water elevation during a 2-year storm, based on the historical channel bottom elevation (prism-out), was selected as the upper limit of rock armoring for banks requiring armor (MDEQ 1998). This elevation occurs at a discharge of 3,845 cubic feet per second (cfs). The Hydraulic Modeling Letter concluded that flow conditions (i.e., channel bottom and wall shear stress and velocities) in the post-construction Western Channel are within the range predicted in the Former Plainwell Impoundment Design Report and, therefore, do not fall outside the design basis for the armor stone size. Rather, a known scour hole that formed during the September 2008 flood event when flow over the water control structure was influencing velocities in that area likely caused a small, local steepening of the bank angle that may have caused the rock to slide and expose the fabric. It is likely that the rock at this location settled after installation and exposed this small area of the geotextile fabric.

To repair this bank, the exposed geotextile fabric will be covered with approximately 20 cubic yards (cy) of an angular rip rap placed from the top of bank. The rock will be 8-inch mean diameter angular stone with a

maximum diameter of 18 inches. The plan view of the repair area and conceptual cross-section are shown on Figure 3. The bank slope is 3:1 and will not be altered by the repair.

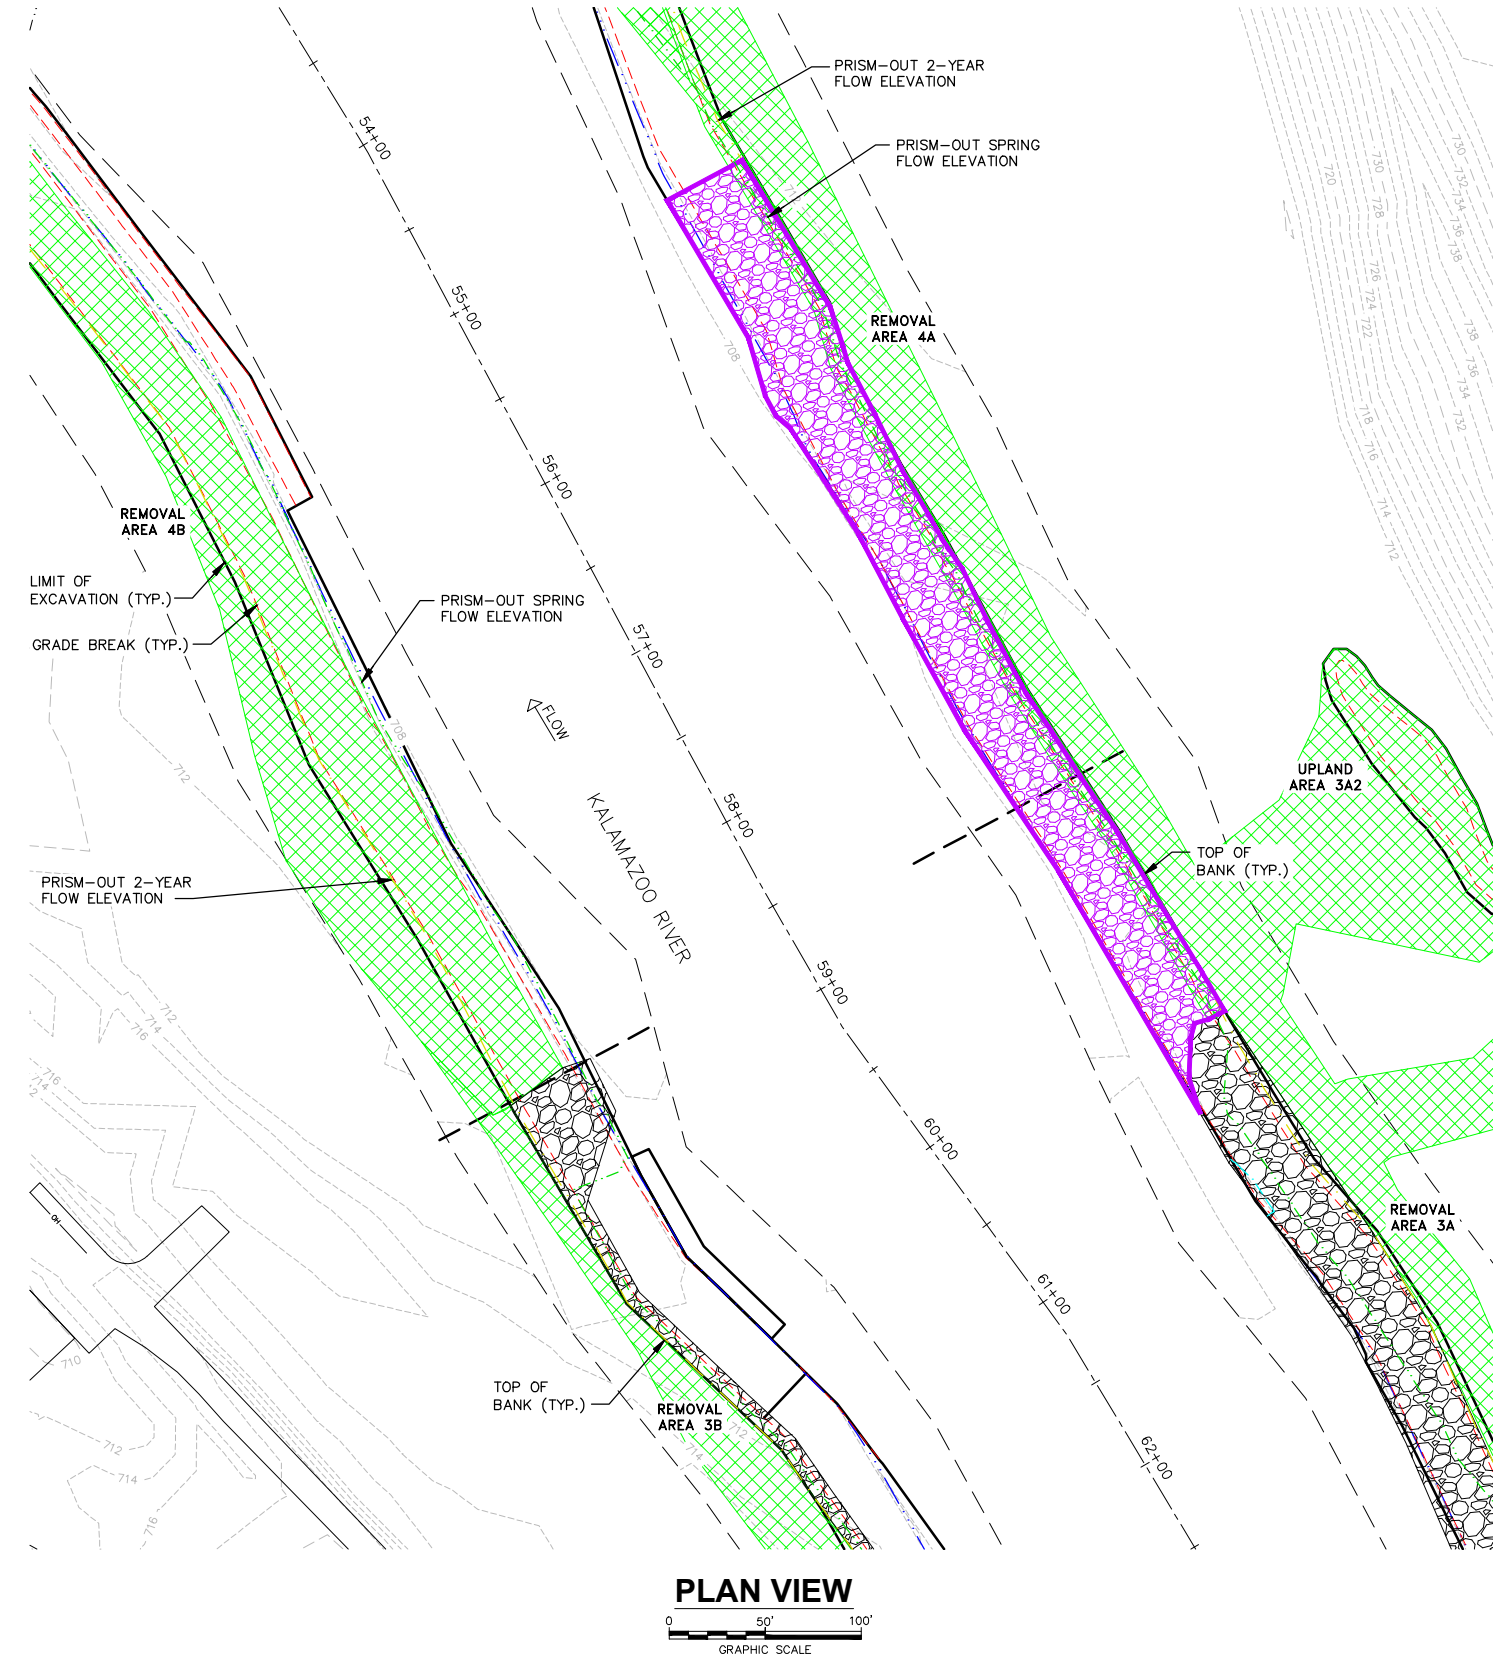
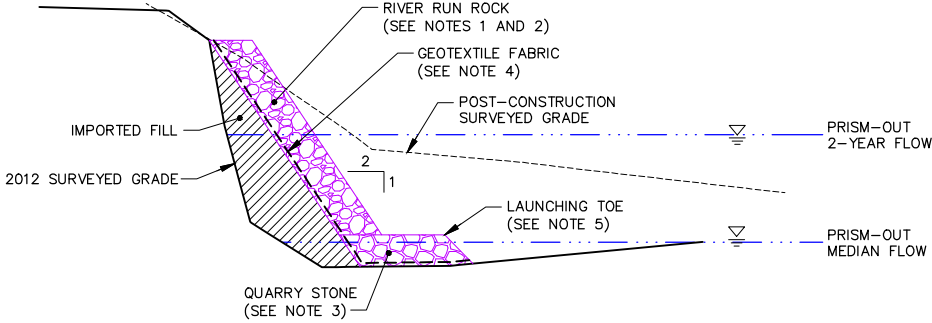
Figure 4 – Former Plainwell Impoundment Removal Area 4A Proposed Bank Erosion Repair Plan and Cross-Section

Approximately 500 ft of bank in Removal Area 4A (River Station 55+00 to 60+00; Figure 4) have been monitored since 2009 and have exhibited signs of continuing erosion. Removal Area 4A is located on the north bank, immediately upstream of the US-131 Bridge. According to the Former Plainwell Impoundment Design Report (ARCADIS BBL 2007), the area was not expected to be subject to erosional forces requiring rock-based armoring following material removal and revegetation activities. Recent site visits noted that the bank vegetation in this area is well established.

Materials that were submerged immediately following excavation appear to have eroded since the completion of the TCRA, which increased the sheer stress before vegetation could become established on the bank. The erosion has the potential to expose polychlorinated biphenyl (PCB)-containing residual materials. The conditions causing erosion of the bank in Removal Area 4A do not appear likely to change in the near-term, so an increase in bank protection is needed. The primary objective of enhanced bank protection is to stop the erosion of the bank to maintain the remaining buffer between the river and bank material that was not excavated as a part of the TCRA.

The exposed bank needs to be covered with clean material to prevent contact between the river and the exposed residuals. The bank can then be armored with stone to the prism-out 2-year storm water elevation (discharge of 3,845 cfs) to prevent erosion of the clean material.

Similar to the 2008 repair performed in Removal Area 7, a rock launching toe will be placed in the channel to isolate the repair area from the flow of the river. Dimensions of the launching toe will be determined in the field based on observed field conditions. Imported fill (180 cy) will be placed behind the rock launching toe at a stable slope. It should be noted that the bank will not necessarily be re-built to its former post-construction dimensions. The bank repair design criteria are to isolate the exposed residuals from the river and to stabilize the bank slope to prevent future erosion. The imported fill will isolate the exposed residuals, and the rock armoring will prevent future erosion of the repaired bank. Therefore, the full 30-foot buffer is no longer warranted. After the fill is placed, the rock launching toe will be laid back on the newly formed bank. Additional rock will be added if necessary in order to bring the top of rock elevation up to the prism-out 2-year storm water elevation (discharge of 3,845 cfs).

As recommended in MDEQ guidance (MDEQ 1998), a non-woven geotextile fabric (7,300 square feet [sf]) will be installed on the imported fill slope prior to rock placement to protect against erosion behind the rock. The rock will be a mixture of 8-inch mean diameter angular stone with a maximum diameter of 18 inches and 6-inch mean diameter rounded stone with a maximum diameter of 12 inches. The local supply of the rounded stone used in the Former Plainwell Impoundment TCRA is limited. To the extent feasible based on available supply, the angular stone will be installed to the necessary thickness and elevation to create a stable slope below the prism-out median water elevation, and the rounded stone will be installed in a minimum 12-inch lift above the prism-out median water elevation to improve the aesthetics. If a stable river bed is encountered at the toe of slope, the rock will be placed on the bed and graded to the prism-out 2-year storm water elevation. If a stable bed is not encountered at the toe of slope, the rock protection will be keyed in below the bed to a depth of approximately 1 ft to protect against bank undercutting.

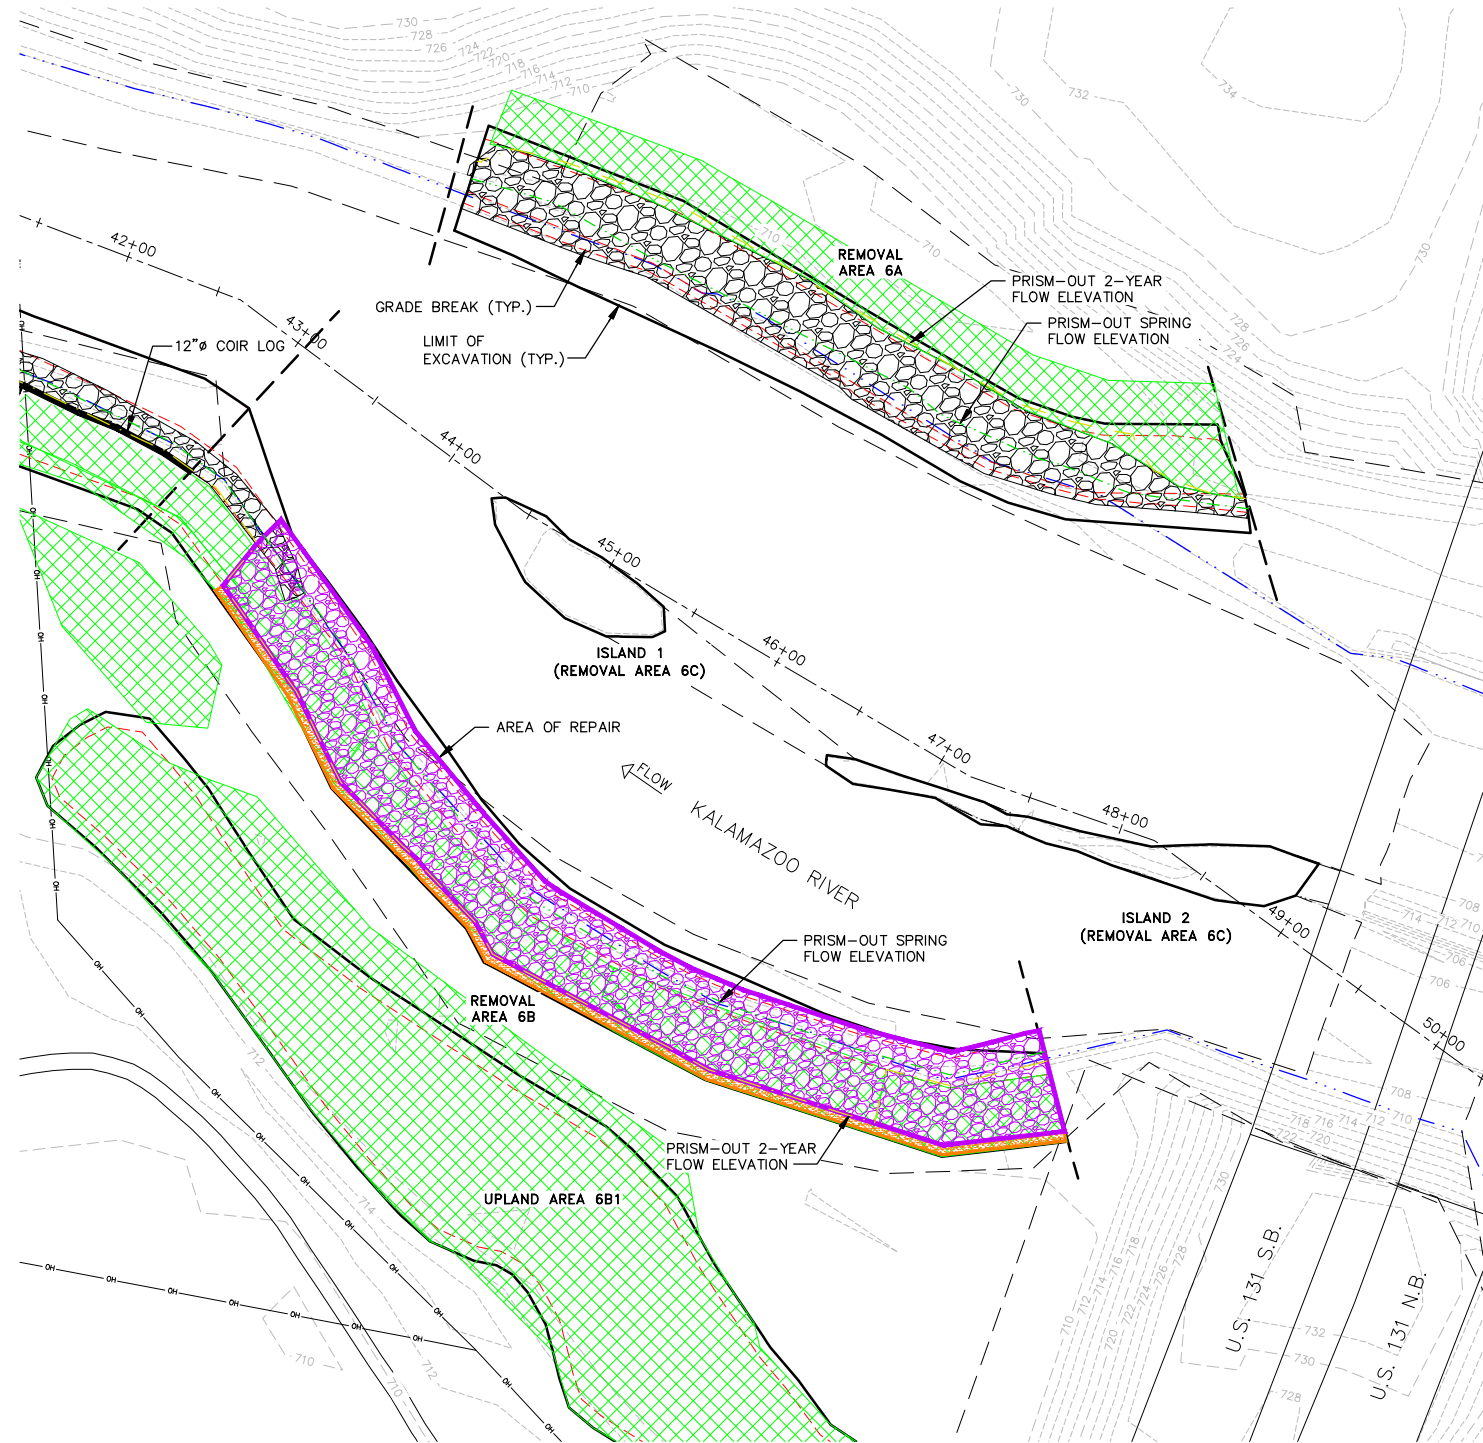
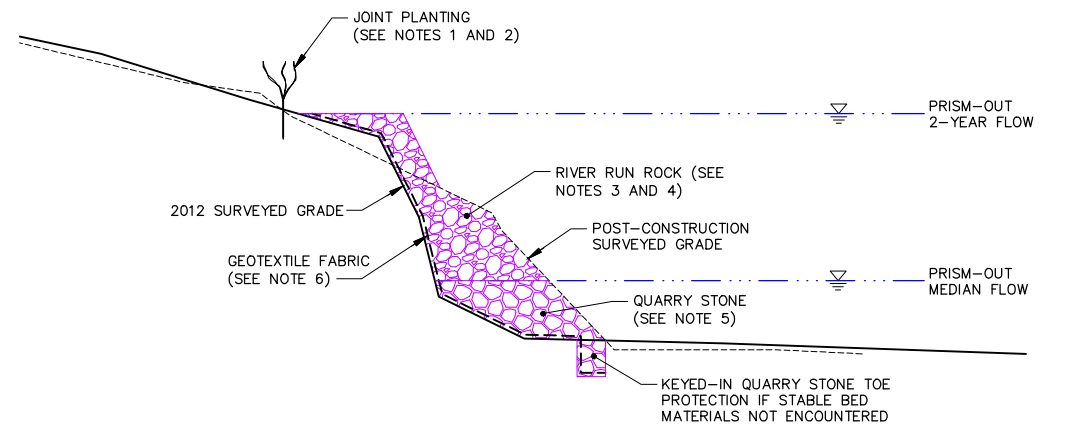
Figure 5 – Former Plainwell Impoundment Removal Area 6B Proposed Bank Erosion Repair Plan and Cross-Section

Approximately 500 ft of bank in Removal Area 6B (Figure 5; River Stations 43+50 to 48+00) have been monitored since 2009 and have exhibited signs of continuing erosion. Removal Area 6B is located on the south bank, immediately downstream of the US-131 Bridge. According to the Former Plainwell Impoundment Design Report (ARCADIS BBL 2007), the area was not expected to be subject to erosional forces requiring rock-based armoring following material removal and revegetation activities. Recent site visits noted that the bank vegetation in this area is well established.

Channel flow is being directed toward the south bank at this location by a mid-channel bar that has established downstream of the bridge. Prior to the TCRA, two islands were present south of the center of the Kalamazoo River, immediately downstream of the US-131 Bridge. Both islands were removed as a part of the TCRA. However, two new islands (gravel bars) have formed in the southern half of the channel downstream of the US-131 Bridge since completion of the TCRA. The new islands are not located in the same locations as the islands removed during the TCRA. The bridge and islands appear to divert water flow towards the banks in a manner that was not anticipated during TCRA design. The conditions causing erosion of the bank in Removal Area 6B do not appear likely to change in the near-term, so an increase in bank protection is needed. The primary objective of enhanced bank protection is to stop the erosion of the bank to maintain the remaining buffer between the river and bank material that was not excavated as a part of the TCRA.

Armoring the bank with stone was concluded to be the best option to address this eroding bank. Therefore, rock armoring will be installed in Removal Area 6B from the toe of slope to the prism-out 2-year storm water elevation (discharge of 3,845 cfs).

As recommended in MDEQ guidance (MDEQ 1998), a non-woven geotextile fabric (9,200 sf) will be installed prior to rock placement to protect against erosion behind the rock. The rock will be a mixture of 8-inch mean diameter angular stone with a maximum diameter of 18 inches and 6-inch mean diameter rounded stone with a maximum diameter of 12 inches, to the extent feasible based on available supply. If a stable river bed is encountered at the toe of slope, the rock will be placed on the bed and graded to the prism-out 2-year storm water elevation. If a stable bed is not encountered at the toe of slope, the rock protection will be keyed in below the bed to a depth of approximately 1 ft to protect against bank undercutting.

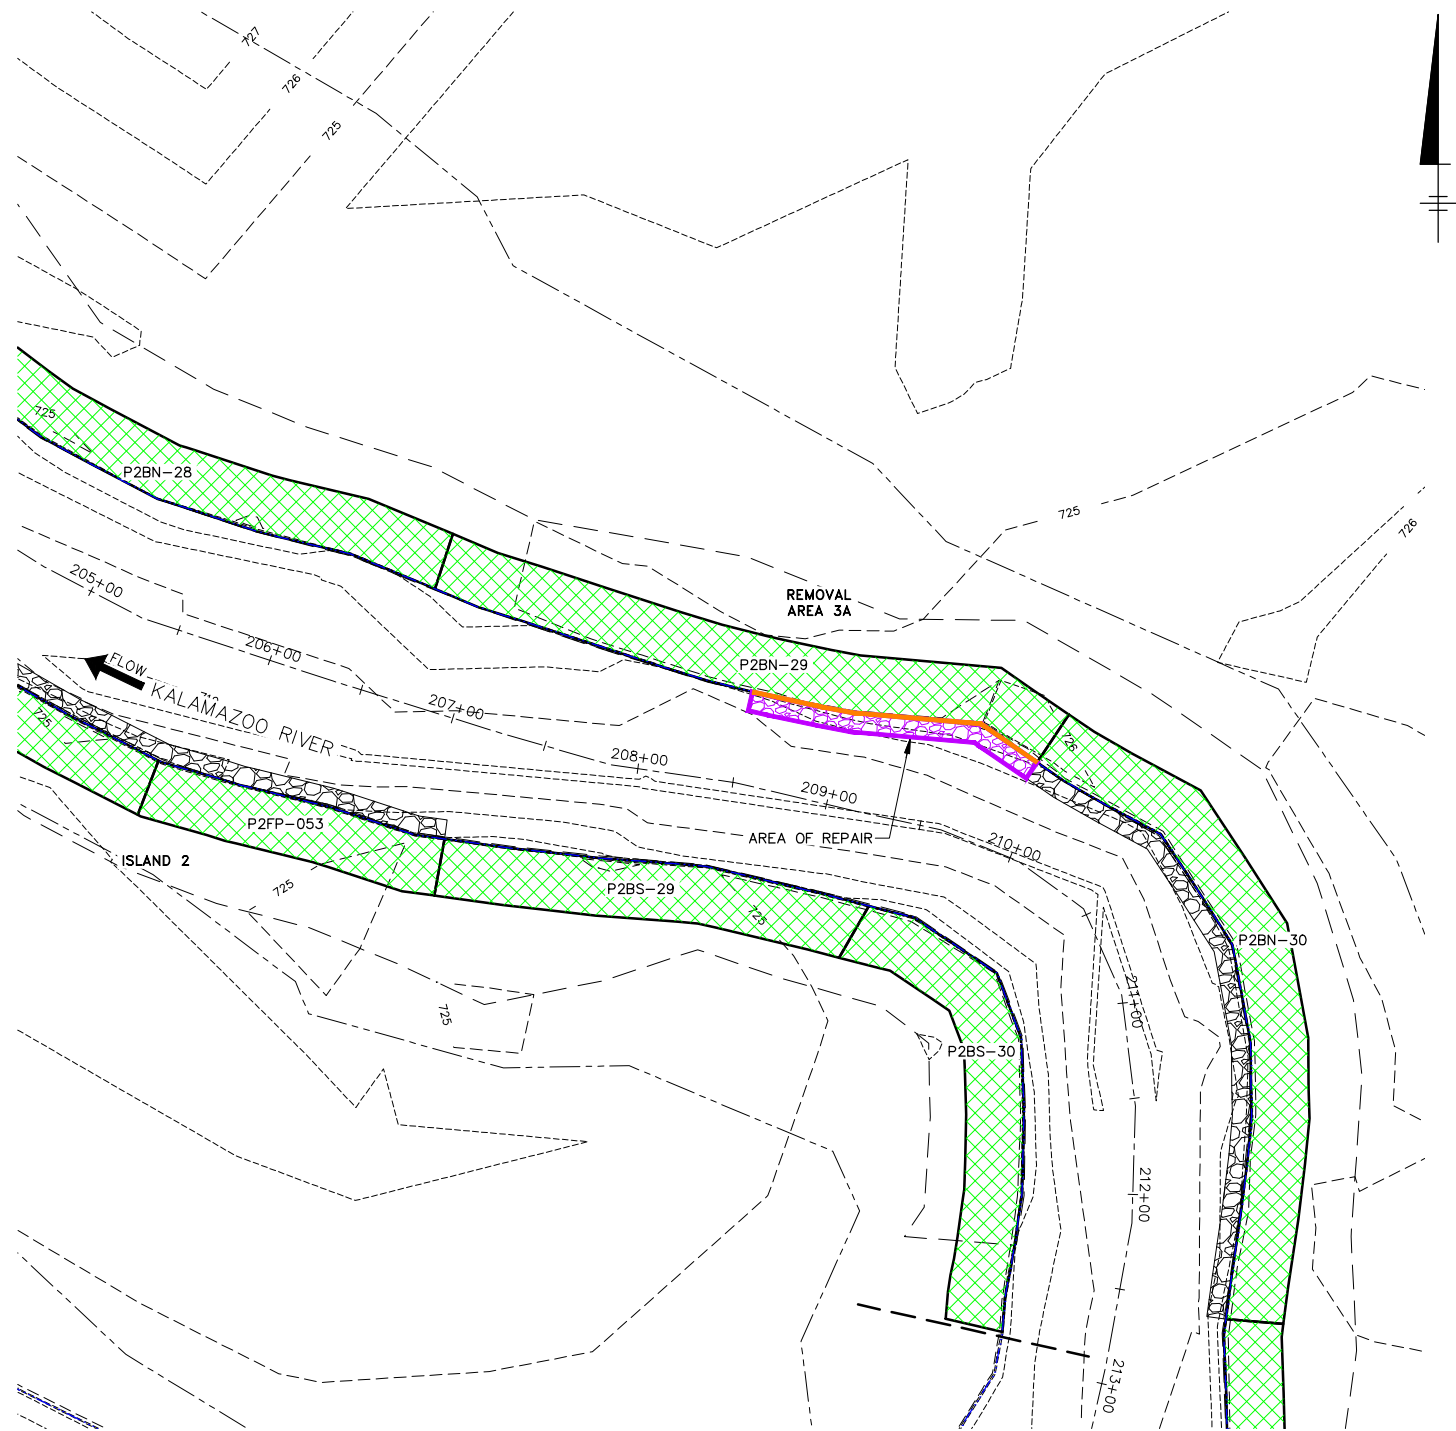
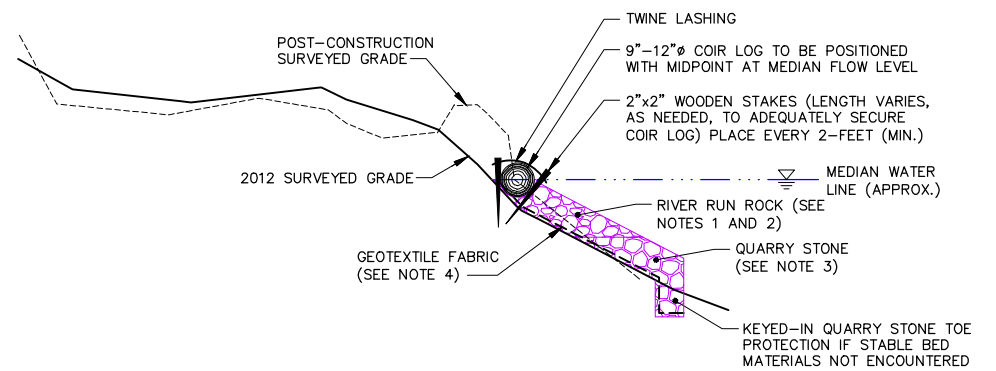
**PLAINWELL NO. 2 DAM  
REMOVAL AREA 3A  
PROPOSED BANK EROSION REPAIR  
PLAN AND CROSS SECTION**

As observed during the August 30, 2012 site walk, approximately 150 ft of bank in Removal Area 3A (Figure 6; River Stations 208+50 to 210+00) is showing signs of having lost bank material and having developed an increased bank angle, which may jeopardize the stability of the bank, should any substantial further losses occur. Removal Area 3A is located at the downstream end of the outer (north) bank of a channel meander. Vegetation density and root depth in this area decreased from 2011 to 2012, resulting from and/or contributing to the increased potential for bank erosion. According to the Plainwell No. 2 Dam Area Design Report (ARCADIS 2009), this area was not expected to be subject to erosional forces requiring rock armoring following removal and revegetation activities.

The observed erosion is related to unanticipated hydraulic forces on the banks that necessitate armoring. Rock toe protection was installed immediately upstream of the observed erosion. Prior to material removal, the bank naturally cut north, away from the main flow of the river at the point of erosion. The existing rock toe protection immediately upstream deflects the water velocity into the downstream un-rocked bank where the erosion was observed. The conditions causing erosion of the bank in Removal Area 3A are not likely to change in the near-term, so enhanced protection of the bank is needed. The primary objective of increased bank protection is to stop the erosion of the bank to maintain the remaining buffer between the river and bank material that was not excavated as a part of the TCRA.

The rock toe protection installed upstream of this bank repair location will be extended approximately 150 ft downstream to form a smooth, consistent toe of slope on the outside of the meander. Toe protection will extend from the toe of the restored bank to the median flow elevation, as modeled in the Plainwell No. 2 Dam Area Design Report (ARCADIS 2009). This elevation occurs at a discharge of 950 cfs. Rock toe protection to this elevation will usually be underwater and not visible except during drought conditions and would allow bank access by semi-aquatic wildlife species that forage along the bank. In addition, a coir log

will be installed at the interface of the top of the toe protection at the median water elevation. The coir log will provide additional energy dissipation and erosion protection at the waterline until bank vegetation establishes enough to provide long-term bank stability. The coir log will be 9 to 12 inches in diameter and secured with stakes and twine lashing as necessary to adequately secure the coir log. A well stabilized toe will prevent general widening of the channel, although some slope adjustment to the bank between the median water level and the top of bank may occur.

As recommended in MDEQ guidance (MDEQ 1998), a non-woven geotextile fabric (1,600 sf) will be installed prior to rock placement to protect against erosion behind the rock. The rock will be mixture of 8-inch mean diameter angular stone with a maximum diameter of 18 inches and 6-inch mean diameter rounded stone with a maximum diameter of 12 inches, to the extent feasible based on available supply. If a stable river bed is encountered at the toe of slope, the rock will be placed on the bed and graded to the median flow elevation. If a stable bed is not encountered at the toe of slope, the rock protection will be keyed in below the bed to a depth of 1 ft to protect against bank undercutting.
